MSG 094 (11-0701) - REPLACEMENT PAGE FOR MSG 075 (11-0688) PAGE 2

II. Port (Triangular) Gap Filler Site Details

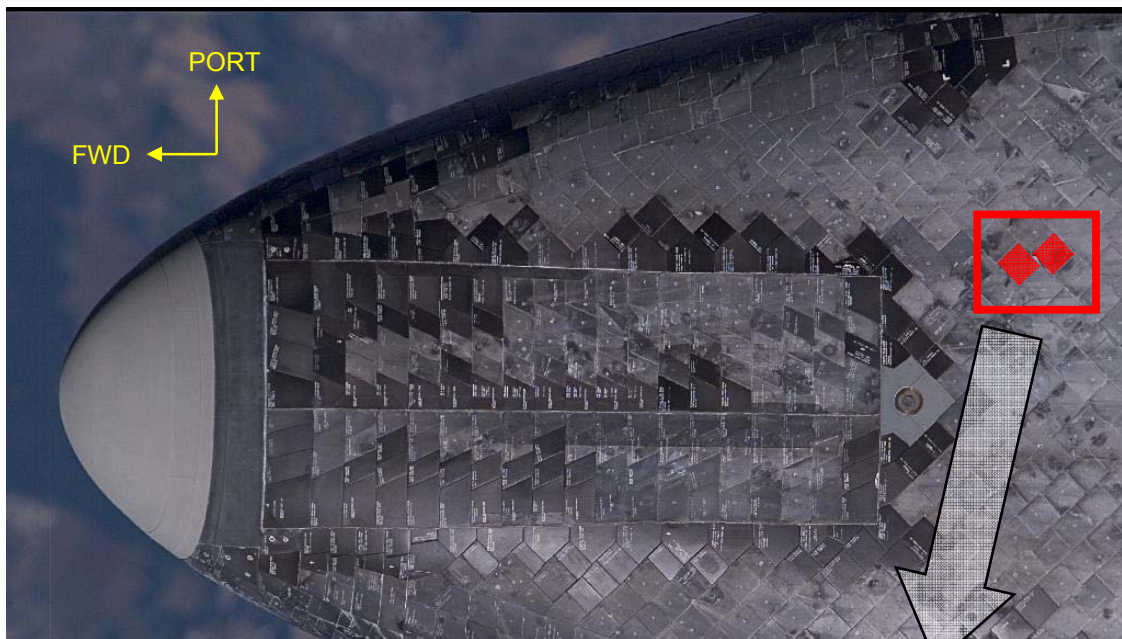
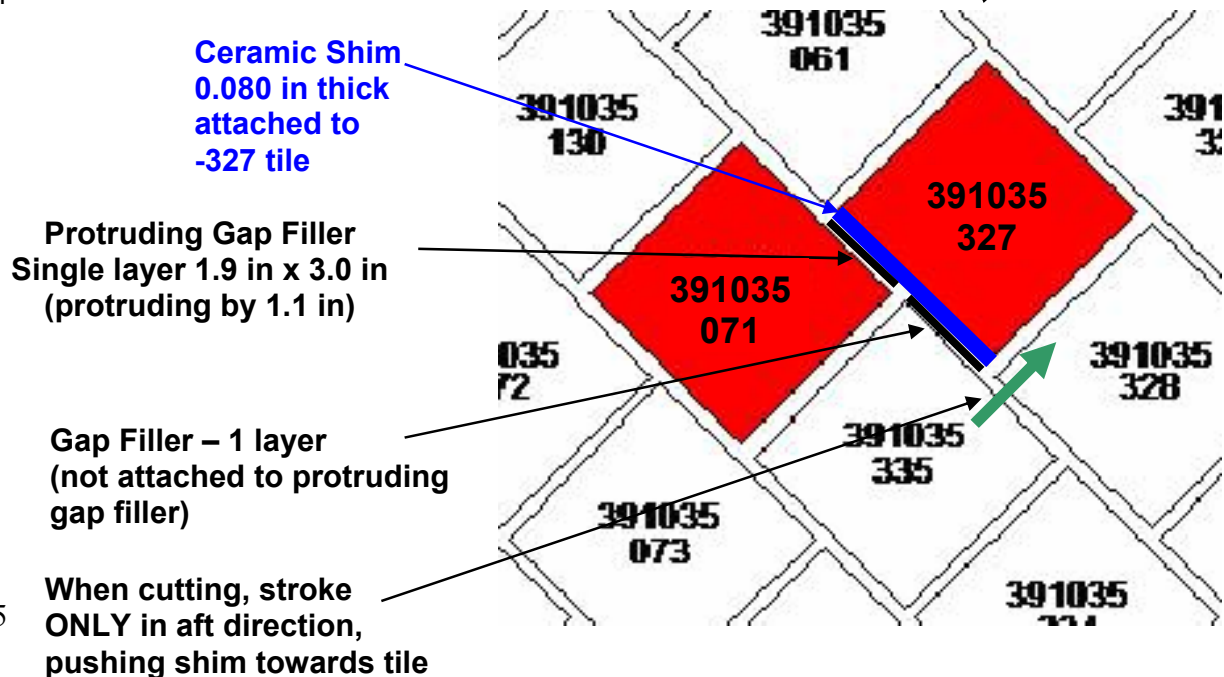
This site is 4 tiles aft of the port edge of the NLGD. The protruding gap filler is a single layer, ~1.9 in x 3.0 in and has the port corner protruding ~1.1 in above the tile. There is a ceramic shim (tile extension) bonded to the tile that's on the aft side of the protruding gap filler. Originally we thought the shim was protruding, but after closer inspection we are confident it is the gap filler only and the shim is still attach to the tile on it's aft side (tile number -327).

is colder, it shrinks, pulling the tiles and gaps closer together. Discovery's skin temperature is around 24F which is believed to be fairly benign, so it is believed that the gap fillers can be pulled out easily.
